INVESTIGATION OF ASPHALT PAVEMENT SLIPPAGE FAILURES ON
RUNWAY 4R-22L, NEWARK INTERNATIONAL AIRPORT

PRESENTED FOR THE
2007 FAA WORLDWIDE AIRPORT TECHNOLOGY TRANSFER CONFERENCE
Atlantic City, New Jersey, USA

April 2007

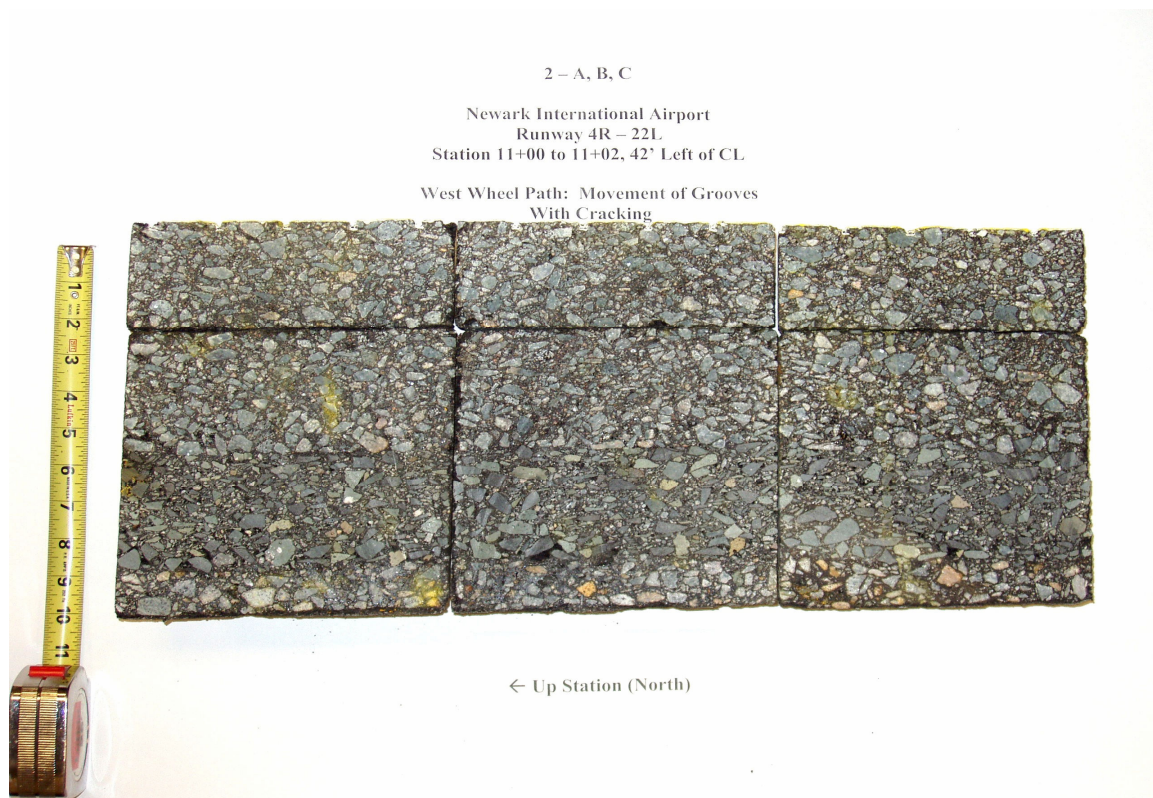
Figure 1. Asphalt Layer Cores from Slippage Areas.

First, the areas containing slippage were cored and evaluated for viscosity, in-place air voids and gradations. These are three basic fundamental characteristics, which describe the overall strength and stability of an asphalt mix. Table 1 shows representative cores taken from the slippage area in both the current asphalt pavement (Contract EWR 154.337) as well as the previous (Contract EWR 653). All investigative cores done under EWR 653 take into account the top lift only.

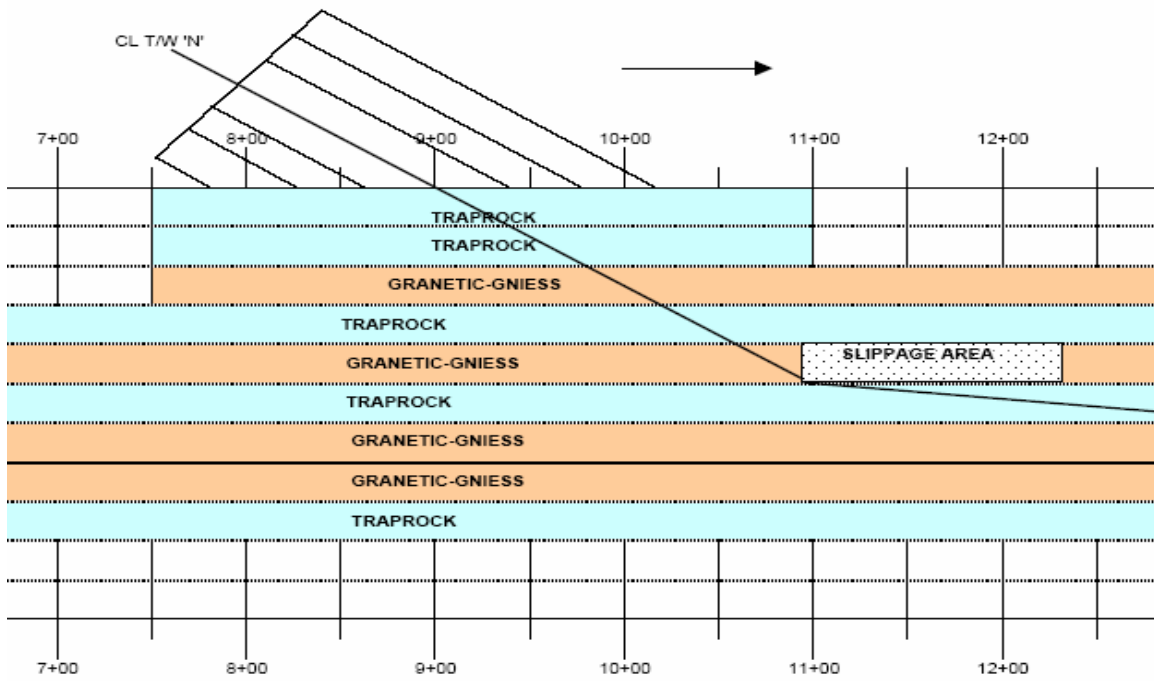
Figure 2 – EWR 154.337 – Top Lift Paving Diagram Showing Aggregate-Type (Top View)

As illustrated in Figures 2 through 7, the majority of the stresses causing the slippage failures take place in the same general location. However under contract EWR 154.337 in which Traprock was supplied as well, the slippage failures are contained within the paving lane width comprised of granetic-gniess. On EWR 653 (Figure 6), the diagram shows that the slippage failures are more widespread into adjacent lanes which are comprised of granetic-gniess as well.

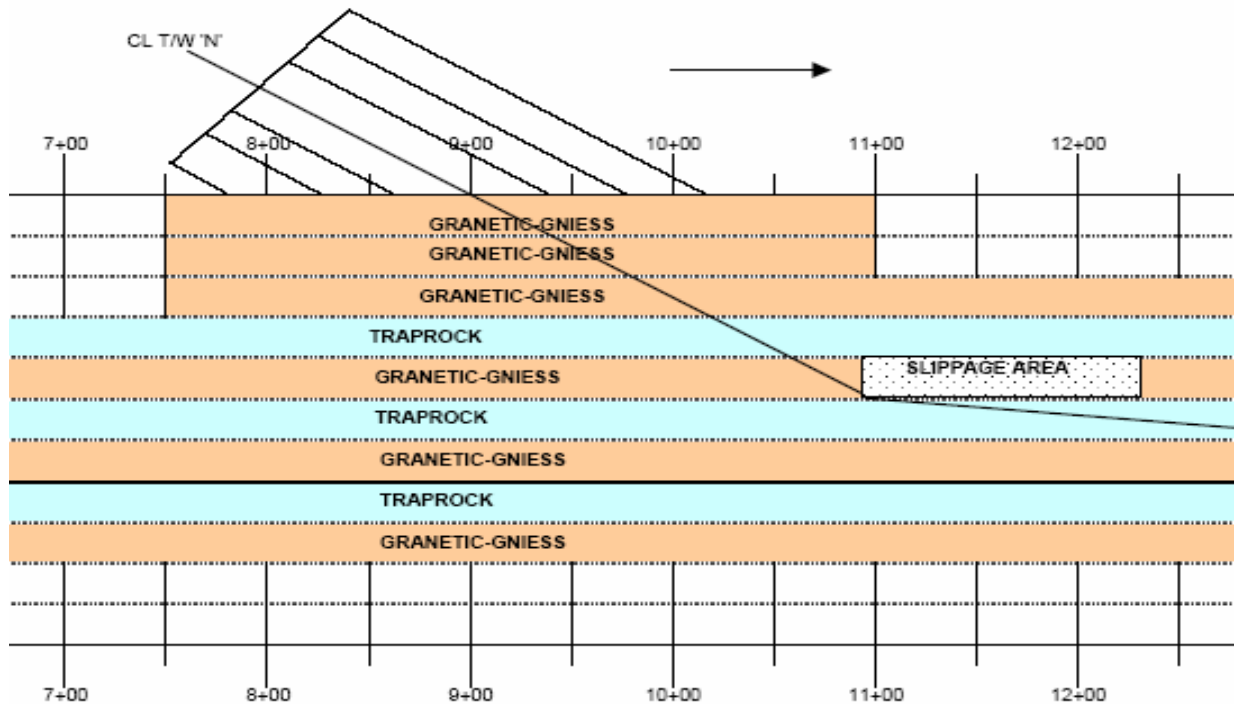
Figure 3 – EWR 154.337 – Bottom Lift Paving Diagram Showing Aggregate Type (Top View)

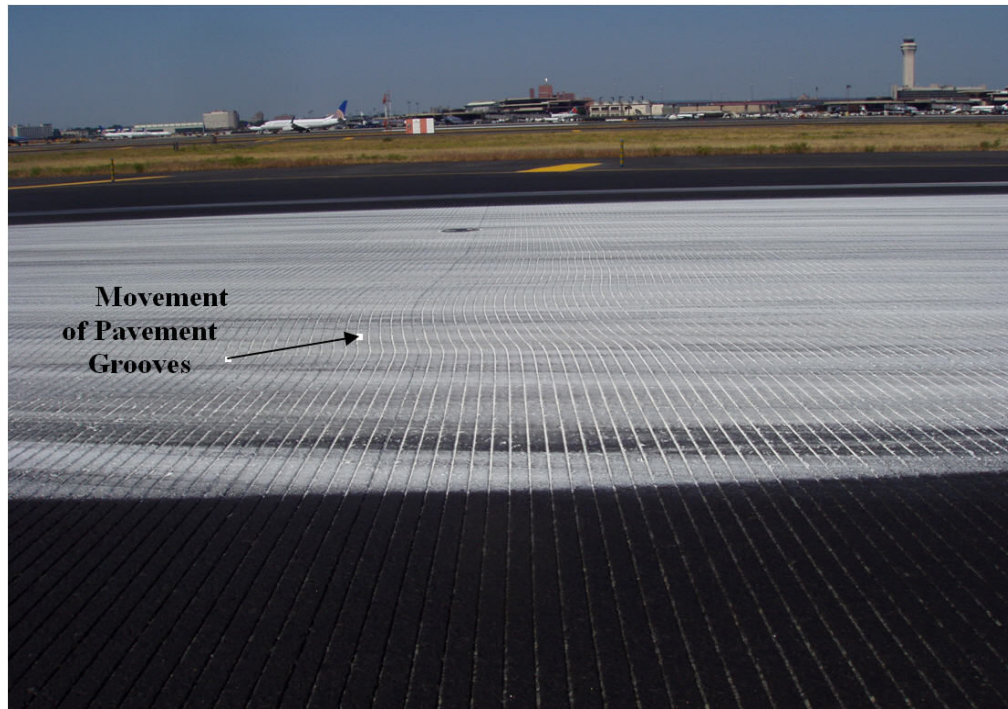
Figure 4. Slippage at High-Speed Taxiway 'N' Under Contract EWR 154.337 (Note "Curved" Grooves Indicating Slippage).

Runway 4R-22L at Newark International Airport, which is primarily a landing Runway, had experienced slippage at the interface of the first and second layer of asphalt in the keel section approaching high-speed Taxiway 'N'. A visual inspection performed in September of 2005 revealed displaced grooves in this area, which appear to be a symptom of heavy braking and shear forces induced by the airplanes as they land and exit the Runway via high speed Taxiway 'N', during the summer. Investigative cores obtained show no indication of failure within the asphalt mix itself, rather a lack of bond at the interface of the first and second lift causing the top layer to slide (Figure 1). It is important to note that during the summer months, airplanes land in the north to south direction which facilitates traffic onto high-speed taxiway 'N'. During the winter months, *when the pavement is stiffer*, the airplanes land in the south to north direction in which the corresponding high-speed taxiways show no signs of slippage.

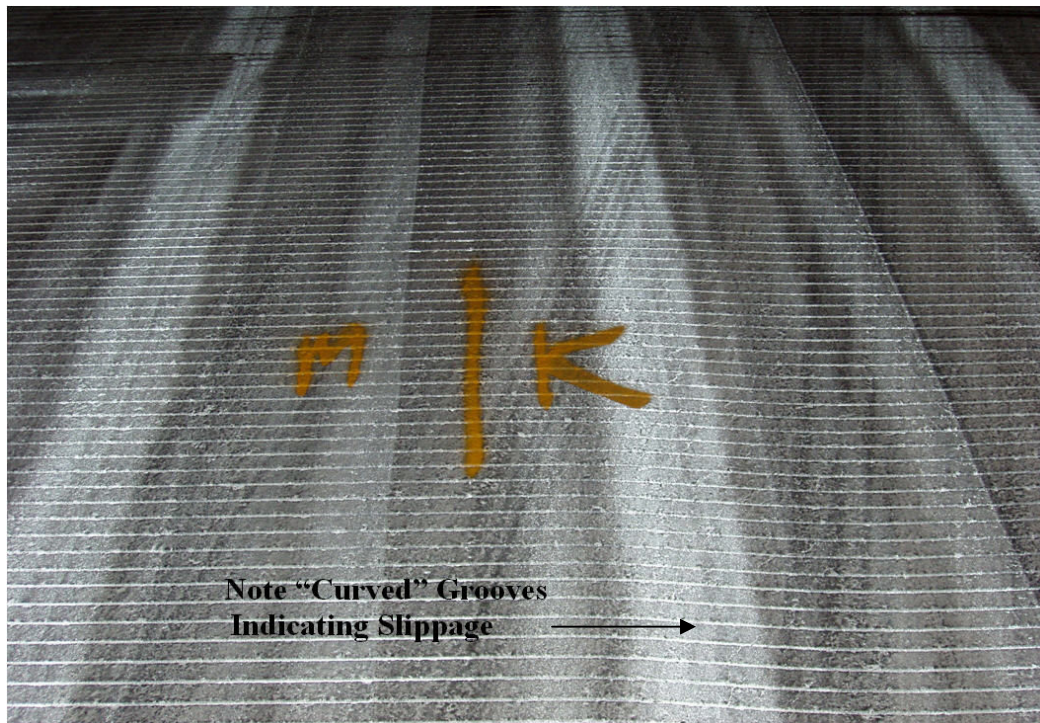
Figure 5. Slippage Observed at Longitudinal Joint (Left of the Vertical Stripe is Traprock; Right is Granetic-Gniess).

The theory of inadequate tack coat or poor band at the interface as a possible culprit for movement in 2005 was ruled out due to the slippage taking place only in the lanes in which the top lift was granetic-gniess. The traprock, although in the vicinity and subjected to the same shear and torsion forces, remained virtually undisturbed.

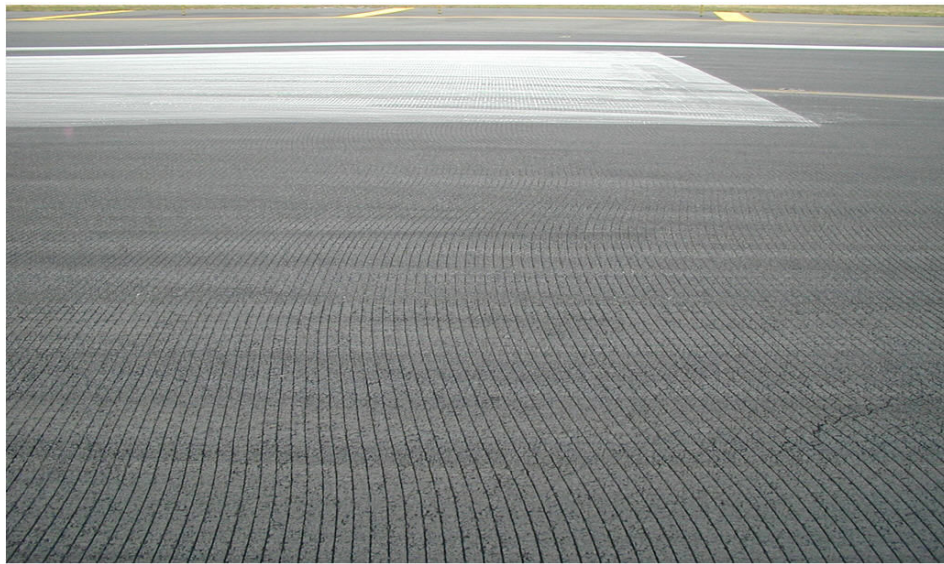
Figure 7. Slippage at High-Speed Taxiway 'N' under Contract EWR 653.

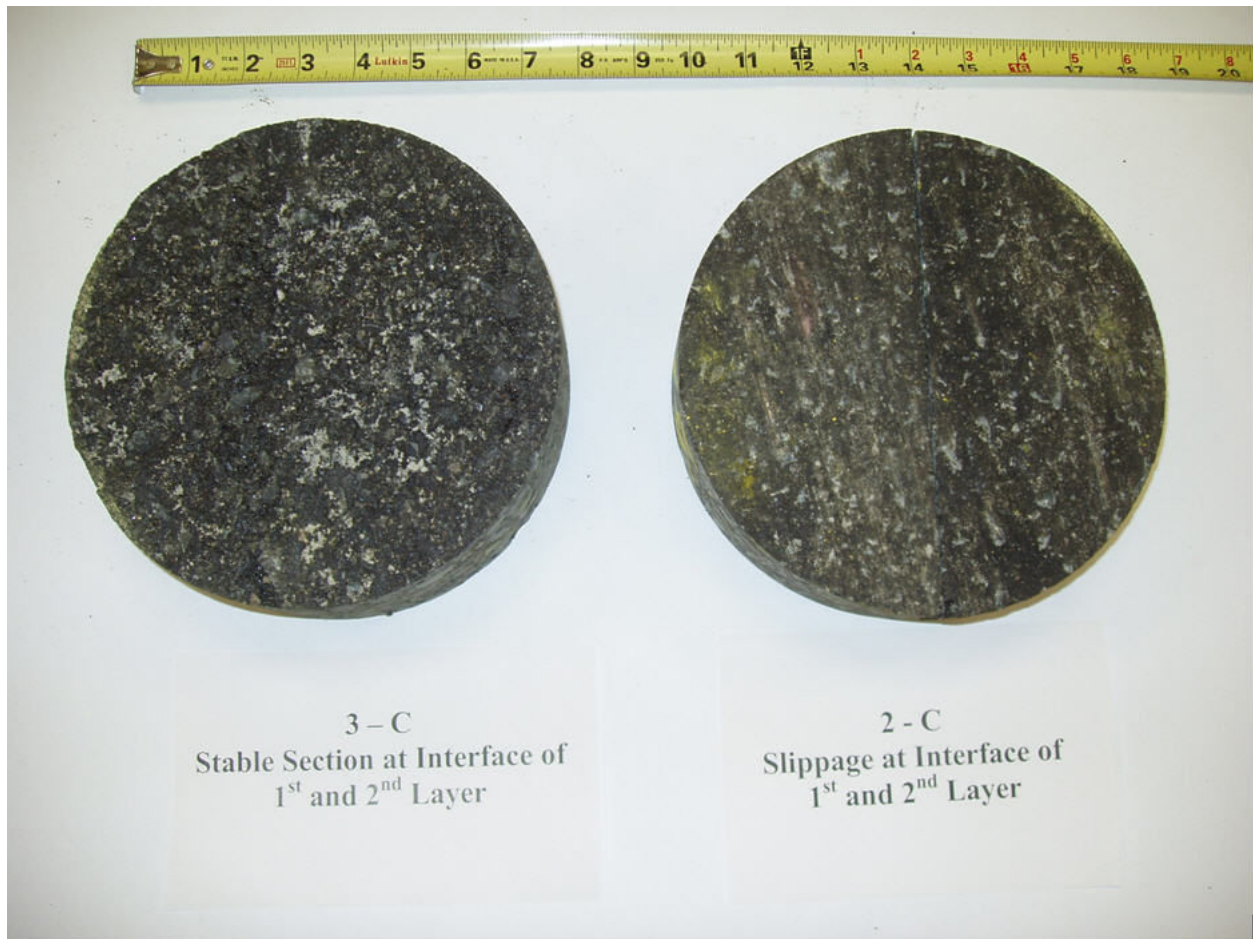
The core samples taken from the field were cut so their cross sections could be viewed. The mix itself appeared stable while there was no bond at the interface of the first and second lift. The interfaces had drag marks on them and were lightly coated with sheared pieces of granetic-gniess (Figure 8). Upon finding no conclusive evidence from the testing thus far as to the cause of the slippage failures, and the fact that these failures took place in the same area twice without affecting areas containing traprock, a more in depth investigation was needed.

Figure 8. Interface of Pavement Lifts from Both the Stable (Left) and Slippage (Right) Areas.

It is recommended that Granetic-Gneiss not be used for high-speed taxiways in the areas subjected to heavy braking and torsion due to this material not providing a sufficient amount of aggregate interlock. Further research needs to be done to determine whether Granetic-Gneiss could be used in this application if the surface of the underlying lift is scarified perpendicular to the direction of traffic, which would provide additional mechanical interlock. The PANYNJ Materials Division will be looking into using a milling machine in the transverse direction prior

to place of the top lift, to provide sufficient mechanical bond. Future work using the SST test procedure on milled and un-milled surfaces are also planned.

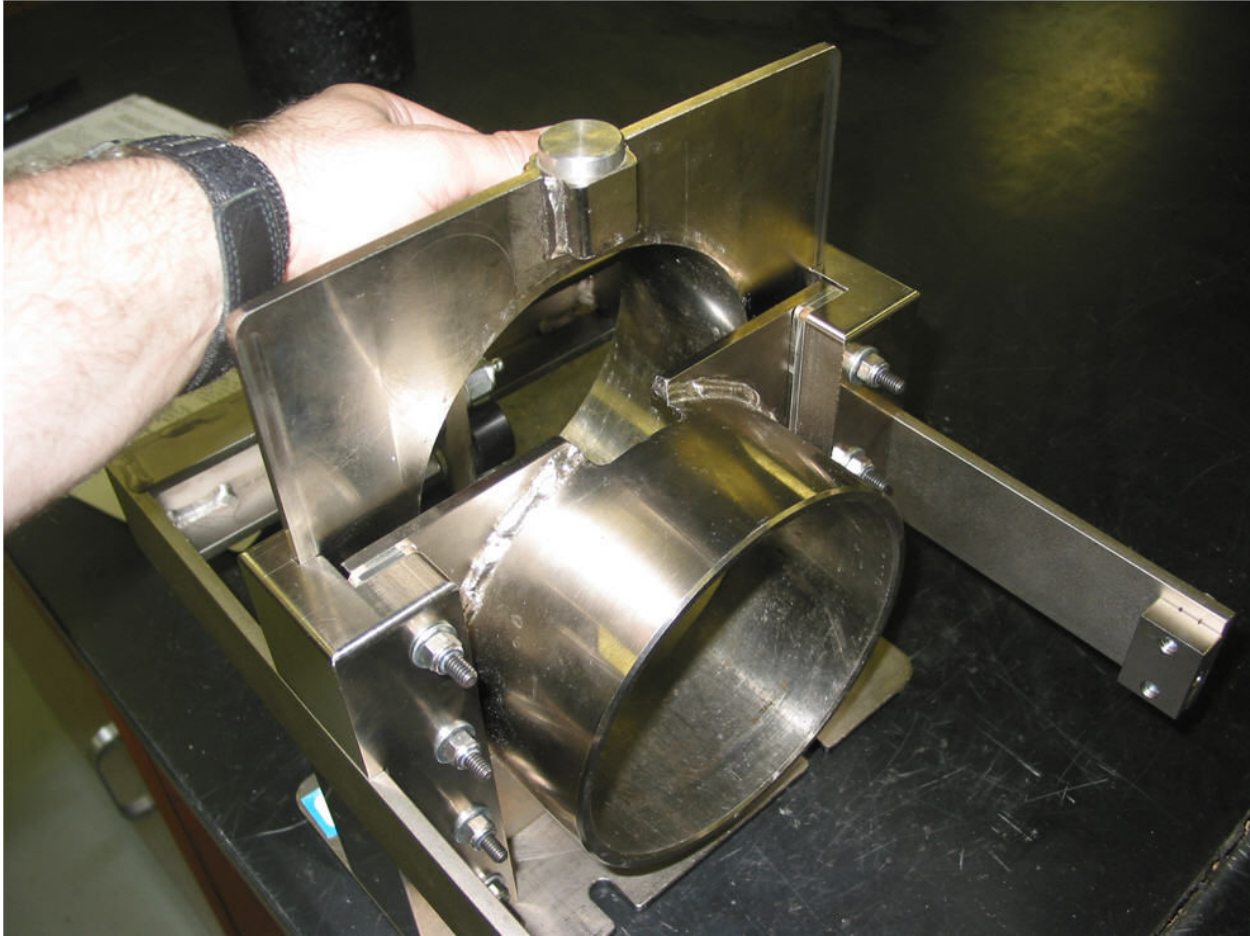
In the past, the bond strength of the interlayer has been typically measured using a static, guillotine-type of shear fixture used to measure ultimate bond strength (Figure 9). Although recent work with this type of test has been recently used by a number of researchers to evaluate optimum tack coat types and application rates [1, 2, 3], the static loading condition utilized does not model the cyclic nature of pavement/airfield loading conditions. To better simulate the loading conditions, a dynamic “pulse-load” test would be preferred over the static strength test. The test method should be able to apply cyclic loading in both the vertical and shear directions, as would occur in the field.

Figure 9. Tack Coat Shear Mold Used by NCAT (Provided by West et al., 2005).

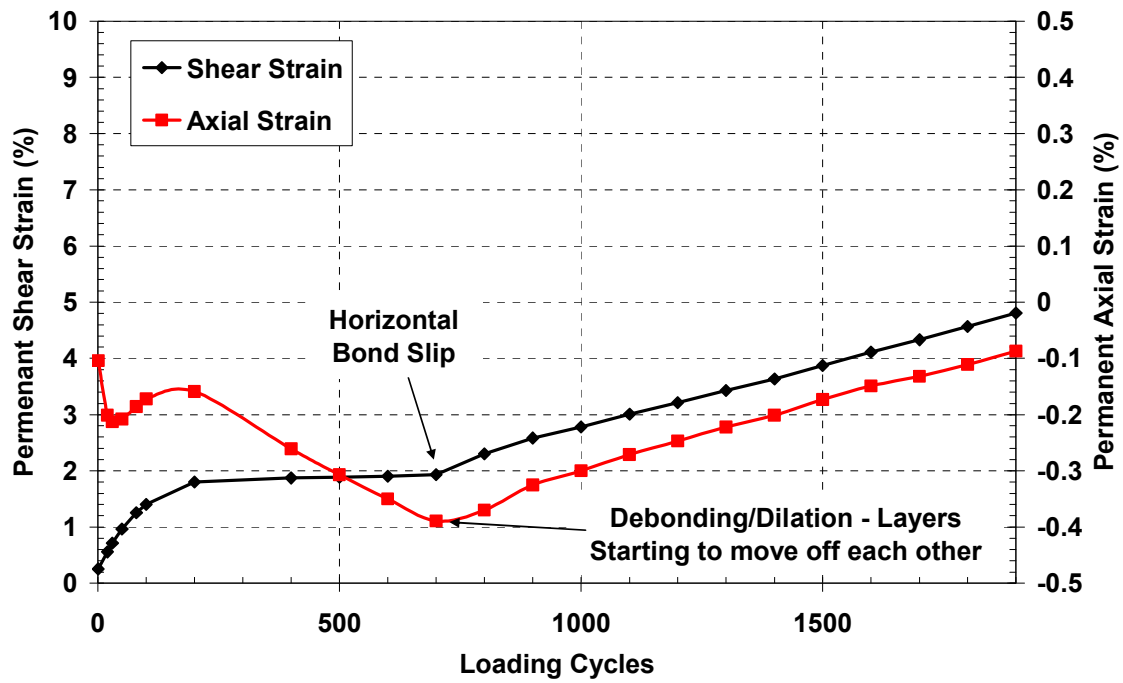
Figure 11 shows an example of some of the initial testing. As can be seen from Figure 11, there is a distinct change in the slope of the vertical strain and shear strain at approximately 700 test cycles. The initial slopes of both the shear and axial strain represent the aggregates at the interface moving until a solid interlock is reached. The downward slope moves towards a minimum plateau at which debonding initiates. Once debonding has initiated, the slopes of both deformations increases steadily and is indicative of the aggregates sliding over each other.

Figure 11. Example of SST Constant Stress Ratio Testing During Test Procedure Development.

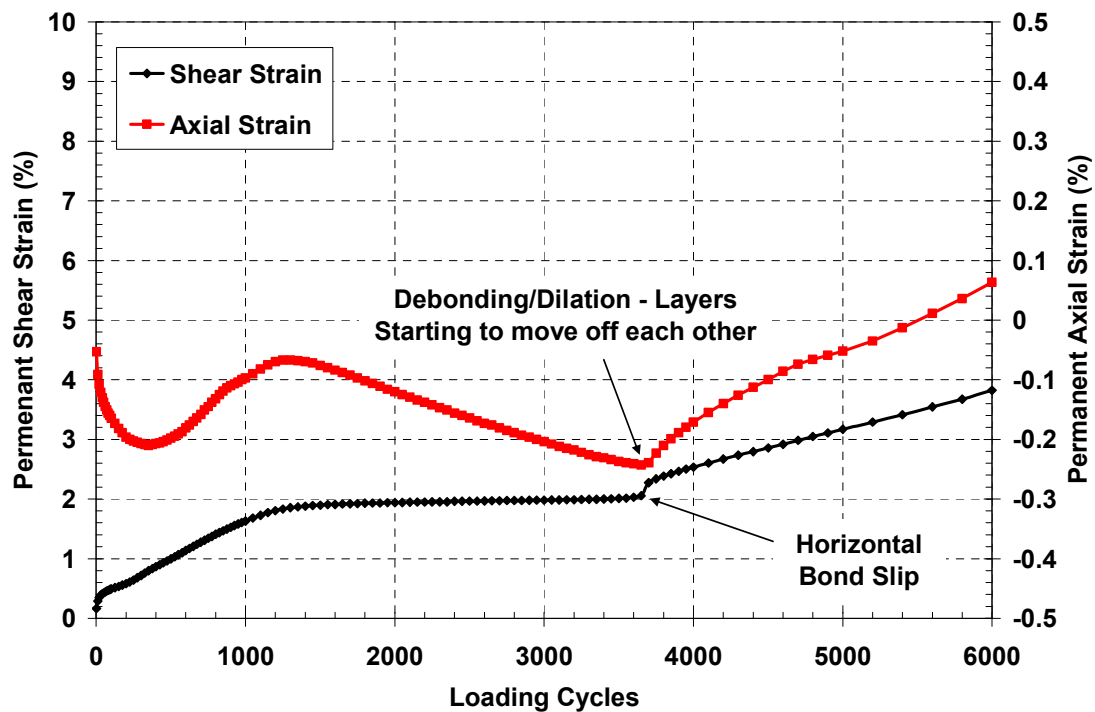
Using the proposed test parameters and the sudden change in the shear and vertical strains to identify the number of load cycles until slippage occurs, a comparison of the three Granitic-Gneiss samples shows that the interface bond broke between 2,800 and 4,450 cycles, with an average of 3,384 loading cycles until the interface bond breaks. A typical plot of the test results of the Granitic-Gneiss samples is shown as Figure 12. The plot clearly shows the sudden change in both the shear and vertical strains.

Figure 12. Typical Plot of Granitic-Gneiss Samples.

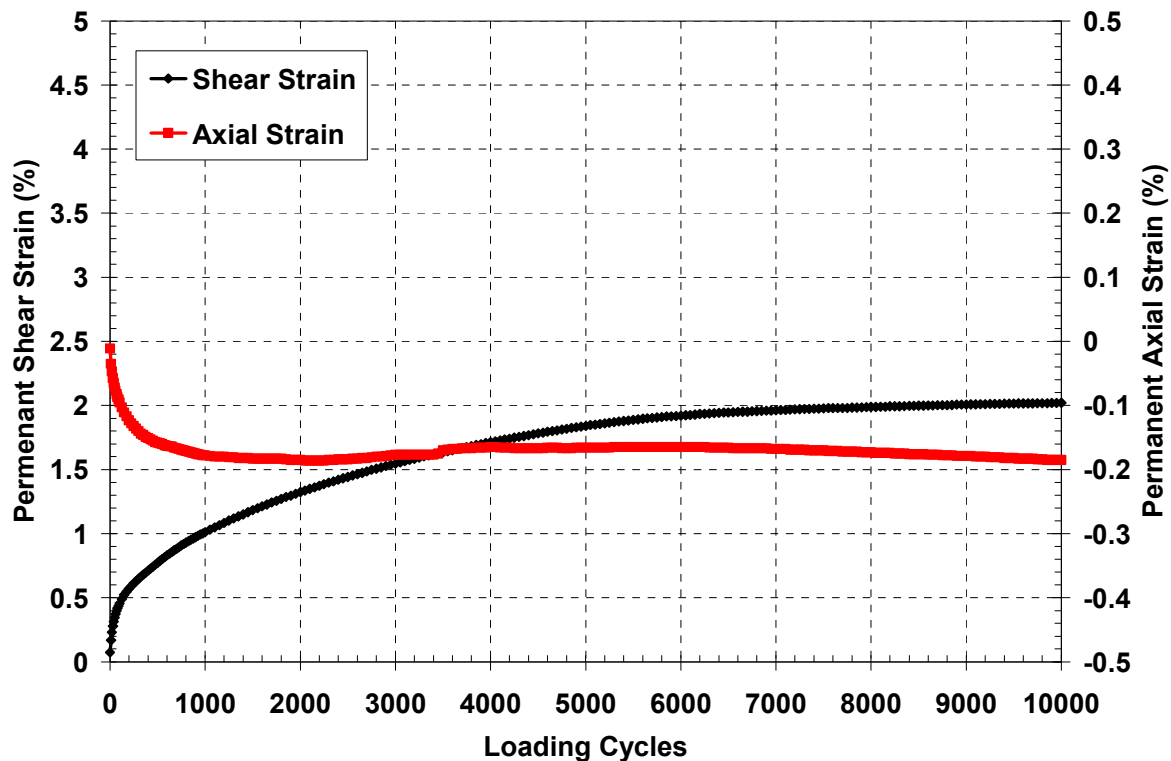
Figure 13. Typical Plot of Trap Rock Samples.

When evaluating the same performance curves for the Trap Rock aggregate samples, there was no indication that a bond had been broken. Figure 13 shows a typical plot of the Trap Rock samples. In fact, the Trap Rock samples perform in an identical manner to HMA samples that do not have a bonded interface. This indicates a strong interface bond where the two HMA lifts perform in a manner that would represent one single layer in the field.
